# Manhole Inspection Summary

Manhole # S49AA\_006MH

Insp Date: **5/8/08 2:32 PM**

**Location** Address: **700 n lakewood ave**

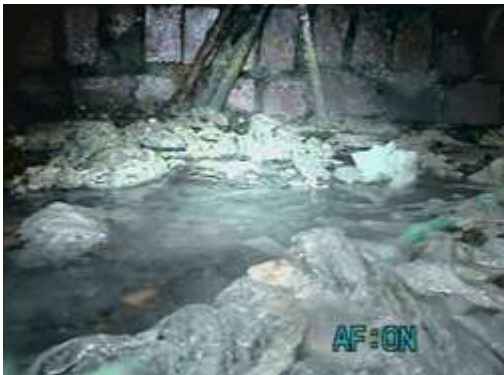
Defect 3

Condition: ☐ Sound ☐ Cracked ☐ Root Intrusion ☐ Deteriorated ☐ Leaks ☒ **Debris**

bench debris

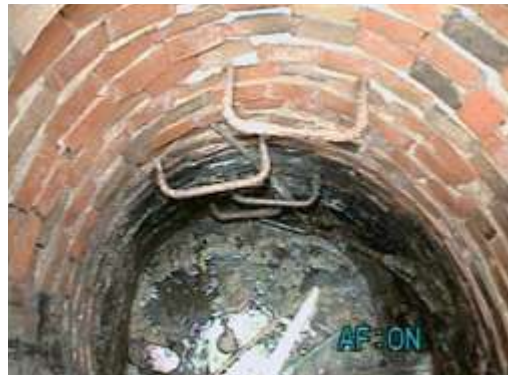
Defect 2

Count: **5** Missing: **0** ☒ **Corroded**

steps

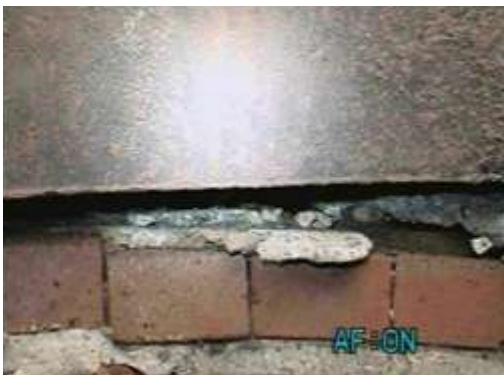
Defect 1

Condition: ☐ Sound ☐ Cracked ☐ Root Intrusion ☐ Loose Brick ☒ **Deteriorated**

deteriorated, frame adj

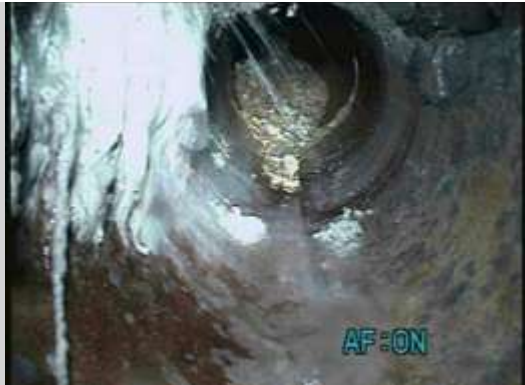
6 O'Clock Inflow

8 in. Circular Gravity Sewer  
Pipe In @ 6 O'Clock

Deposits: ☐ None ☐ Mud ☐ Sludge ☒ **Debris** ☐ Grease

Silt Depth: **4** (in.) Deposits Extent: **Medium**
